# GLOBAL JOURNAL OF ENGINEERING SCIENCE AND RESEARCHES

## INFLUENCE OF CVD MULTILAYER COATING ON MACHINABILITY CHARACTERISTICS OF AEROSPACE GRADE STAINLESS STEEL

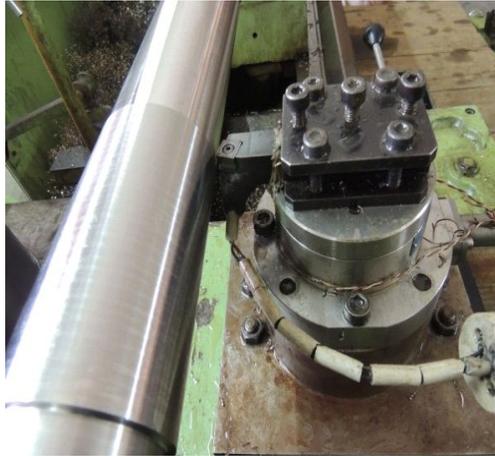
**Fig.1 Photograph of experimental setup for turning of 17-4 PH Stainless steel.**

Tests were conducted to investigate the effect of tool materials and cutting speed on cutting force, tool wear, chip thickness, and machined surface roughness. Tests were focused on turning operation with variation of cutting speed. The dry turning of 17-4 PH SS was carried out with both uncoated and coated carbide insert at variable cutting speed for different machining duration using a heavy duty lathe machine (Make: HMT Ltd., India and model:NH26) as shown in Fig. 1. Three different cutting speeds were selected during the machining as 140, 190 and 210 m/min along with a constant feed (f) of 0.24 mm/rev and depth of cut (t) of 1 mm. Each of the experimental run was carried out for machining duration of 60 s. Cutting force was measured using four-component piezoelectric dynamometer (Model: 9257B Make: Kistler, Switzerland) in combination with a charge amplifier (Make: Kistler Instrumente AG, CH-8408 Winterthur, Switzerland; Model: Type 5814B1). Surface roughness of each experimental run was measured with Talysurf (Model: Taylor Hobson, Surtronic 3+) with parameters sample length, Lc=0.8 mm, cut-off length, Ln= 4 mm and filter=2CR ISO. After each interval of machining duration the state of the cutting insert was monitored with the help of stereo zoom optical microscope (Make: Radical Instruments) to determine the tool wear
